## Turn Signal Malfunctions Diagnosed

(All 1964½-1966 Mustangs).

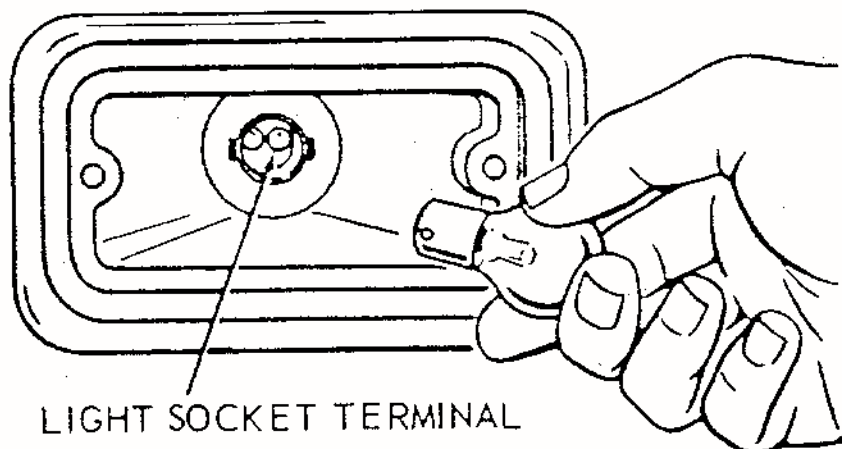
**(1) Complaint:** One front turn signal light will not operate. Dash panel indicator operates and parking light operates.

- a. Burned out or broken light bulb filament.
- b. A defect in that part of the circuit between the light socket and the lead disconnect.

- a. Substitute a good bulb. If bulb does not light, use following test.
- b. Check for power at the turn signal light socket terminal. (See Fig. 1). If there is no power, check for power at the connections between the light socket and terminal block.
