Power Steering Oil Cooler Rattle Noise Corrected

—1974 Mustang with Power Steering

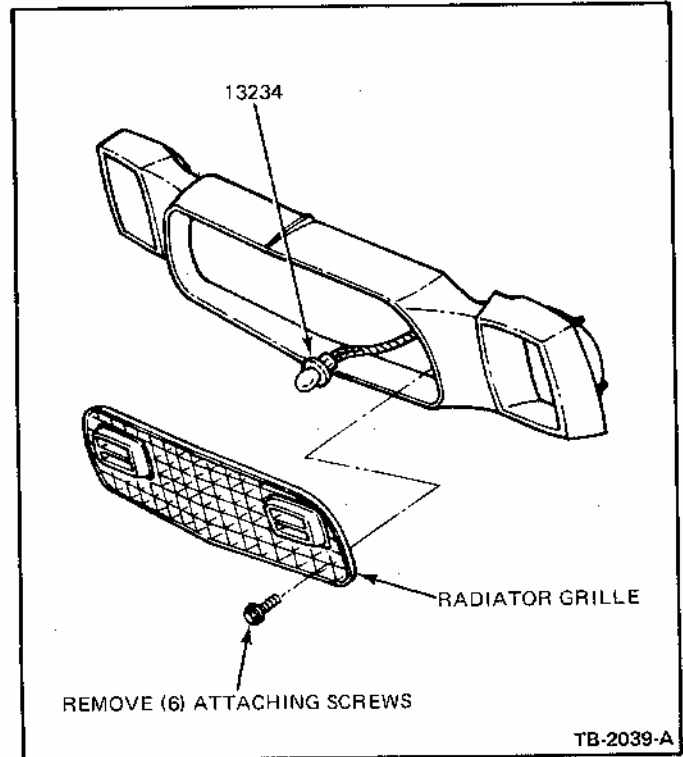
Fig. 6 – Article 756

A noise coming from the front area of the car may be caused by a loose and/or broken power steering oil cooler mounting bracket.

1. Open the hood and remove the two (2) parking light bulb and socket assemblies from the parking lights by rotating the socket counterclockwise and pulling them out of the light body. (See Fig. 6).

2. Remove the six (6) grille attaching screw and remove the grille. (See Fig. 6).
3. Remove the stripped out self-tapping screws from the cooler assembly brackets.

2. Remove the six (6) grille attaching screws and remove the grille. (See Fig. 6).
3. Remove the two (2) top bolts from the radiator support-hood latch but do not remove the support bracket entirely. (See Fig. 7).
