## Water Leaks — Cowl Top To Side Panel Joints

### 1965-66 Mustangs

Information for "The Troubleshooter" is taken from Ford Motor Company Technical Service Bulletins issued to dealer service departments

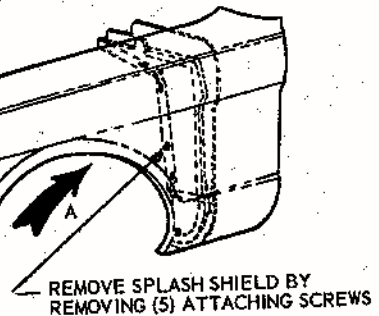
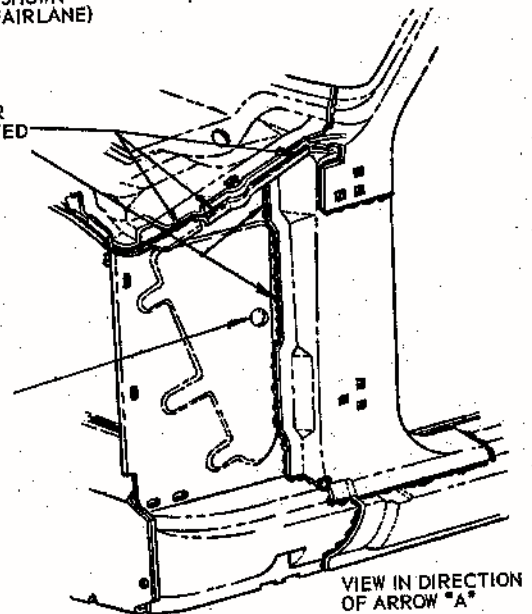
Illus. S1068-A — Water Leaks - Cowl Top to Cowl Side — 1965-66 Mustang and  
1966 Falcon, Fairlane — All Models — (Article 841)

Reports from the field indicate water leaks occur at the cowl top to cowl side flange joints due to inadequate sealing of the joints and that dealers remove the front fender to gain access to seal these areas. Investigation into this problem has shown that access to seal the joints can be obtained by removing the splash shields and that fender removal is not required.

LEFT SIDE MUSTANG SHOWN —  
(TYPICAL FALCON, FAIRLANE)

Dealers encountering customer complaints relative to water leaks in this area should add liquid butyl (Part Number C5AZ-19554-A) or caulking cord (Part Number AB-19560-A) to the affected areas as outlined in the following procedure and accompanying sketches.

1. To gain access to the cowl top and cowl side panel weld flanges, remove the front wheel and splash shield. The splash shield is retained with five screws.
2. Apply liquid butyl or caulking cord along the flange areas sufficiently to seal any open seams. See illustration.
3. Check the plug buttons in this area and seat them if necessary. Cover the edges with liquid butyl to seal.
4. Water test vehicle to assure adequate sealer application.
5. Reinstall the splash shield and wheel.

APPLY LIQUID BUTYL (C5AZ-19554-A) OR  
CAULKING CORD (AB-19560-A) TO AFFECTED  
AREA

SEAT THE RUBBER PLUGS IF  
THEY ARE NOT SEATED AND APPLY  
LIQUID BUTYL (C5AZ-19554-A)
