## Insufficient Heat

### —1974 Mustang w/Standard Heater

## Ash Receptacle Lid Interference At Forward Edge of Console Panel

## Engine Dieseling And/Or Run-On After Ignition Key Is Turned Off

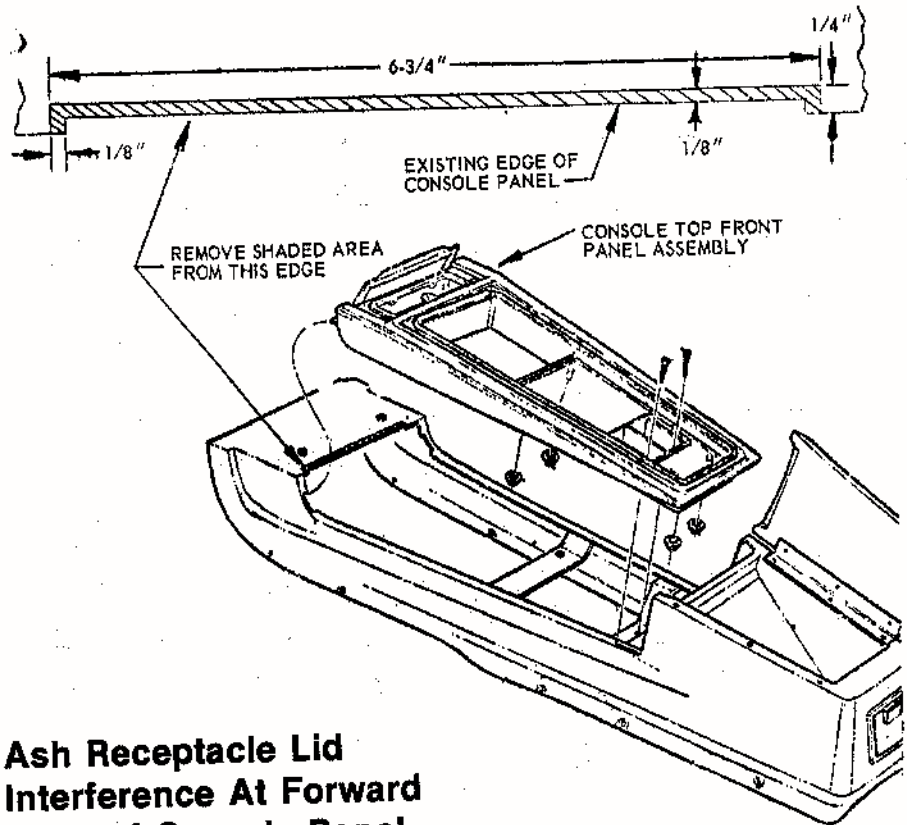
Figure 2 - Ash Receptacle Lid

When binding ash receptacle lids are encountered in vehicles built prior to the production correction, the swing clearance can be increased as described below:

2. Remove the console top front panel assembly to gain access to the front edge of the console panel as shown in Fig. 2.

3. Increase the size of the existing ash receptacle opening in the console panel by 1/8" as shown by the shaded area on Fig. 2.

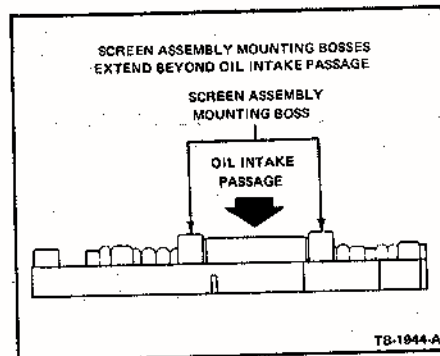
Fig. 7 - Article 671

## Elimination Of Spacers Between Screen Assembly And Main Body Control

The main control body casting has been revised to eliminate the need for the three spacers between the screen assembly and main body control. When removing the main control, inspect the screen assembly mounting bosses and the part number cast in the control body.

If the part number cast into the control body is 74DT-7A101-BB (early design), the screen assembly mounting bosses are the same height as the oil intake passage. Spacers **must be used** between the screen assembly and the control body on these assemblies. If the part number cast into the control body is 74DT-7A101-BC (later design), the oil screen mounting bosses extend beyond the oil intake passage (See Fig. 7). Spacers **must not be used** on this assembly. If the three spacers are omitted between the screen assembly and control body on the early design, or if the three spacers are used with the revised design, the pump will cavitate resulting in low control pressure and transmission malfunction.
