# Door Handle Deformation Complaints On '66 Ponies

The Mustang Times/March, 1993

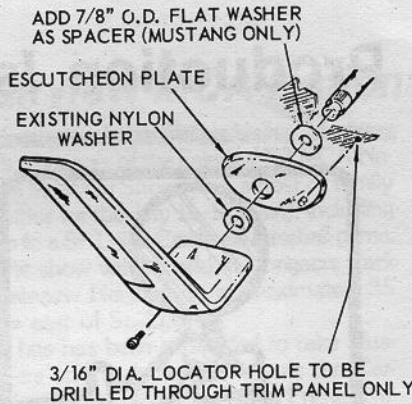
Some units may show evidence of a deformed or scored inside door handle escutcheon. Investigation has revealed that the escutcheon locator hole was not positioned correctly in the door trim panels on some models and was omitted entirely on other models. As a result of this, the locator pin on the escutcheon could not be seated correctly on the trim panel, thereby permitting deformation and/or scoring of the escutcheon.

Fig. 10 - Deformation of Inside Door Handle Escutcheon Plate - (Article 559)

1. Remove the door inside handle and escutcheon.

2. Obtain a new escutcheon and locate it correctly by pressing the escutcheon firmly against the trim panel.

3. Pierce or drill a 3/16-inch diameter hole through the trim panel only at the indentation made by the locator pin on the escutcheon. (See Illustration).

**Note:** In some cases a mislocated hole may already exist in the trim panel. If it interferes with an attempt to locate the new hole, enlarge the existing hole to allow correct escutcheon installation.

4. Position the escutcheon and install the door handle.

**Note:** A 7/8 O.D. flat washer should be added between the trim panel and escutcheon.
