OUR 2004 PROJECT CAR GETS NEW HEADLIGHTS.

Our project car for this Mini-Tech is a 2004 6 cylinder Mustang with a serious headlight problem.

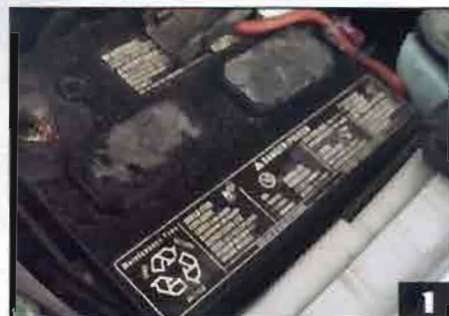
▲ Safety is always paramount. Before we began, the battery was disconnected.

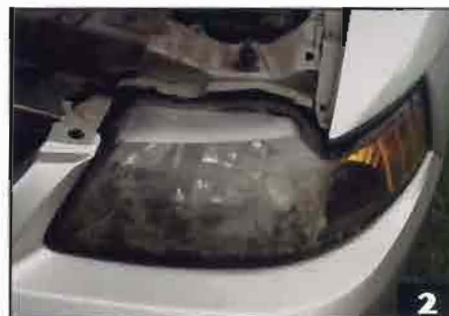
▲ One headlight was totally broken, the other wasn't in such great condition.

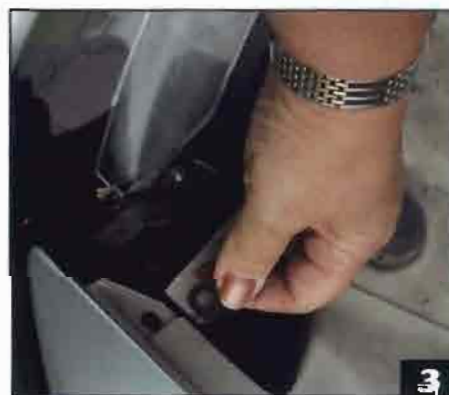
▲ First, the retaining clips, long slender clips that hold the headlight to the panel, were removed.

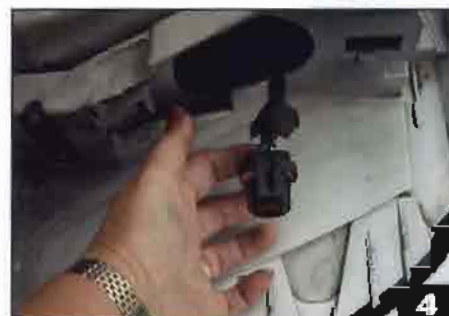
▲ After the assembly was released from the Mustang, the headlight bulb connector was removed from the headlight.

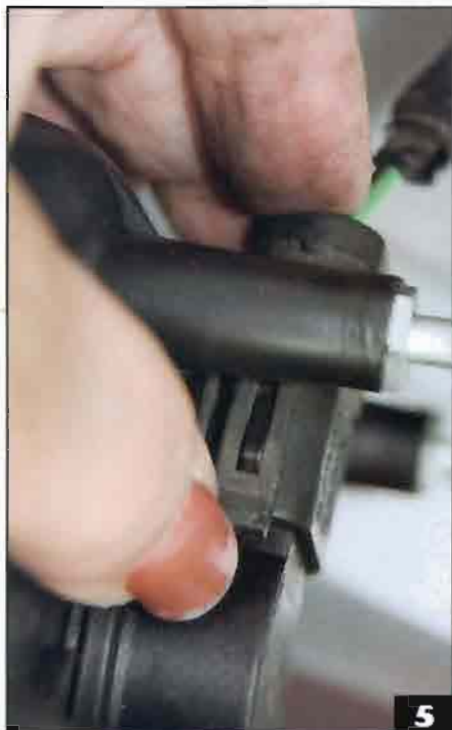
5

▲ Next, the clip on the electrical connector on the sidemarker bulb was released.

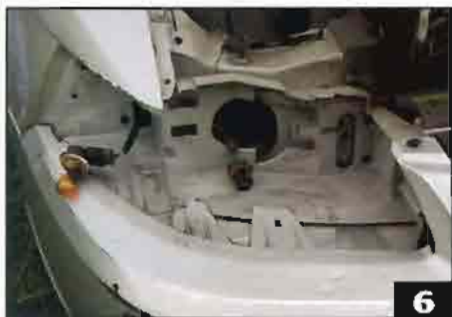
6

▲ Once the headlight was totally removed from the Mustang, we took the opportunity to give the area a good cleaning.

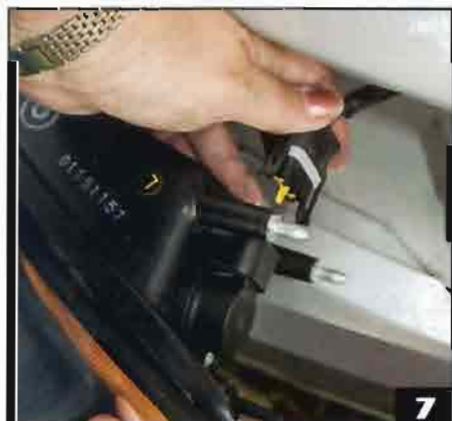
7

▲ The sidemarker connector was first reattached by simply pushing it until the clip snapped into place.

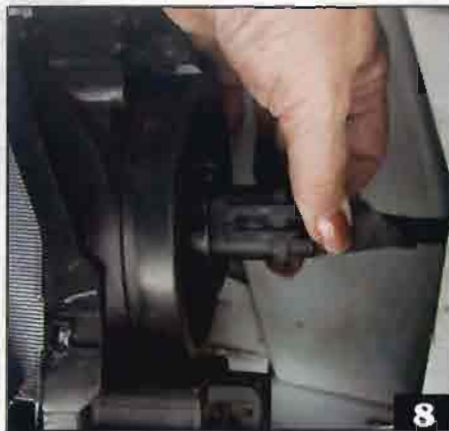
8

▲ Next, the headlight switch was connected to the assembly.

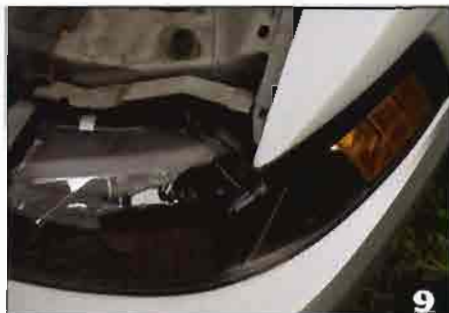
9

▲ The headlight assembly was fitted into place. Before it's even complete, the headlight already looks much better.

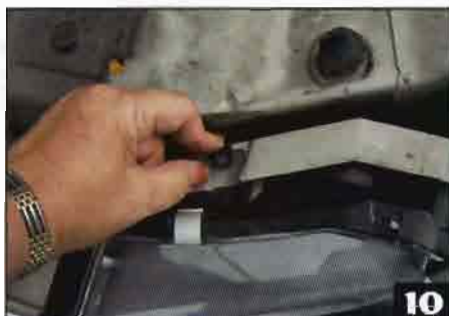
10

▲ Next the first of two headlight retaining clubs in pushed back into place.

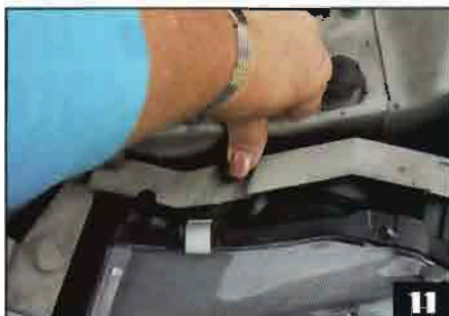
11

▲ I gave the clip a second push to be sure it keeps the assembly secured to the body.

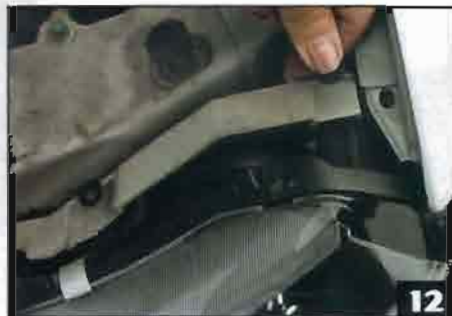
12

▲ The second retaining clip is at the outer edge of the assembly. That was also secured properly.

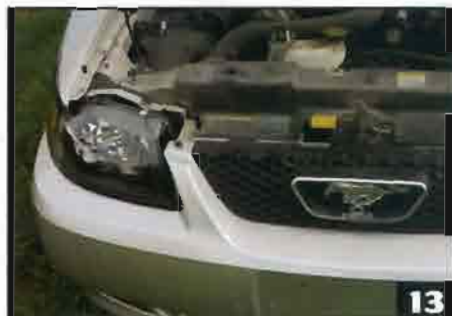
13

▲ No more broken headlight.

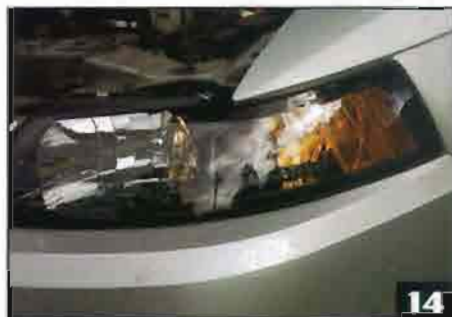
14

▲ Both headlights are replaced. It's a good idea to get them aligned properly. We connect the battery and tested the lights.
