DOES YOUR PONY CAR HAVE TORN OR CRACKED DOOR PANELS, WELL THEY CAN BE RECOVERED AS GOOD OR BETTER THAN NEW, BY FOLLOWING THESE FEW SIMPLE TIPS: 1965-66 MUSTANG

MUSTANG HARDTOP DRIVER'S SIDE FRONT

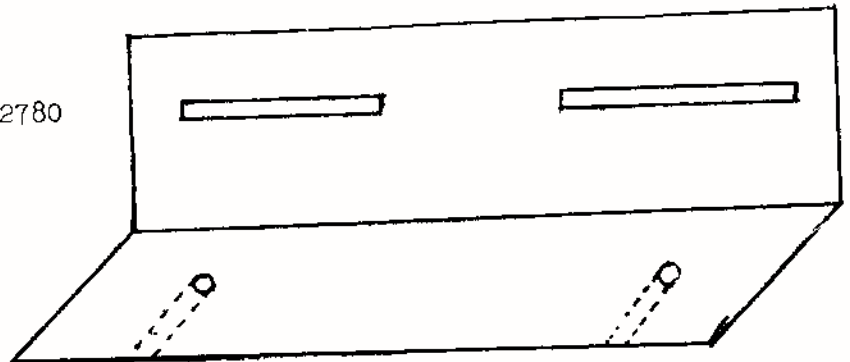
1. Remove rubber pad in bottom of pull cup located in center of molded arm rest.
2. Remove the (2) flat-head screws exposed by Operation #1.
3. Remove allen-head screws in center of window crank and door handle, remove window crank and door handle.

4. Remove screw or screws through back edge of outer stainless steel trim.
5. If car is equipped with optional remote mirror, remove control head and disconnect lead cables.

6. Take a flat object (like a putty knife), insert between door panel and door, slide either direction until hitting a clip and pry outward. Continue this operation until all clips are out of door.

7. Remove all clips from back of panel, package panels, pull cups and pads and ship to address below.
8. Prior to installation of new panels, mark location of L bracket mounted on door. Remove L bracket, with a pair of tin snips modify bracket as shown with dotted lines in sketch below. This will allow an adjustment of bracket height. Replace bracket approximately 3/8" higher than originally installed.

SPECIAL NOTE: Upon receiving your new panels, you will notice that the top edge of the pull cup is touching the bottom edge of inner stainless steel trim, it should remain in that position after panel installation. It may be necessary to position panel on door more than once to match bottom of pull cup with top of L bracket, make adjustment to L bracket to assure pull cup is not drawn down into hole when the (2) flat-head screws removed in Operation #2 are reinstalled.

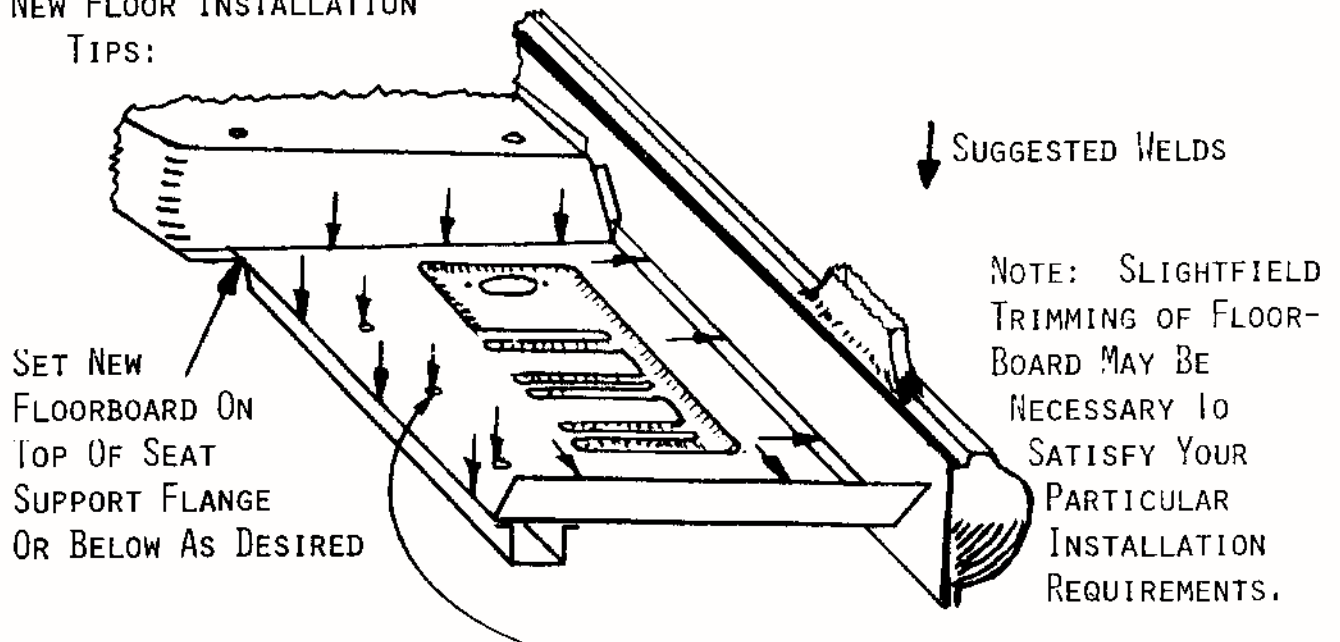
NEW FLOOR INSTALLATION TIPS:

SPOT, TACK, WELD, OR POP RIVET FROM TOP AS DESIRED.

CONVERTIBLE CARS DO REQUIRE FIELD TRIMMING BECAUSE OF DIFFERENT FRAME STRUCTURE. WE TURNED THE FLANGE DOWN ON THE ROCKER PANEL SIDE FOR EASIER WELDING ON THESE MODELS.
