DIAGNOSING HYDRAULIC TAPPETS

To diagnose clicking noises which may be attributed to possible hydraulic tappet problems, proceed with the following steps:

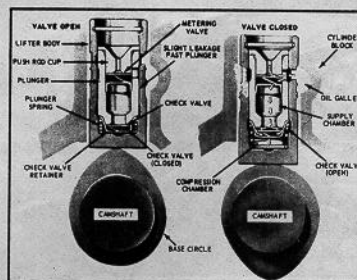
If the noise is still present it may be necessary to check for low oil pressure, oil aeration, oil cleanliness, etc. Oil aeration check should be performed as follows:

- a. Operate the engine until normal operating temperatures are reached.
- b. Stop engine and remove oil pressure sending unit.
- c. Install a petcock type valve into the sending unit opening which will permit attachment of a ¼" to ¾" diameter hose of sufficient length to reach the oil fill opening. Close the valve.
- d. Operate the engine at approximately 500 RPM for five minutes, then open valve slightly to permit steady oil discharge and observe for air bubbles.

- e. Increase engine speed to 1000 RPM and recheck for air bubbles.
- f. If aeration is present, inspect the oil pump intake system for leaks and repair as required.
- g. If no aeration is detected, remove aeration checking device and install hydraulic testing gauge to check engine oil pressure at normal operating temperature. Engine oil pressure at the sending unit should be 35-55 P.S.I. at 2000 rpm.
- h. If oil pressure is below specification, check for excessive wear in the oil pump, as indicated in the shop manual, and sticking of the oil pump relief valve. If the oil pump assembly is within specifications, check other lubricating clearances in the crankshaft, camshaft, etc.
