REPAIRING MUSTANG FOLDING CONVERTIBLE REAR WINDOWS

In regard to the letter from Janet K. McKie in the December issue of Mustang Times, I think I might be of help.

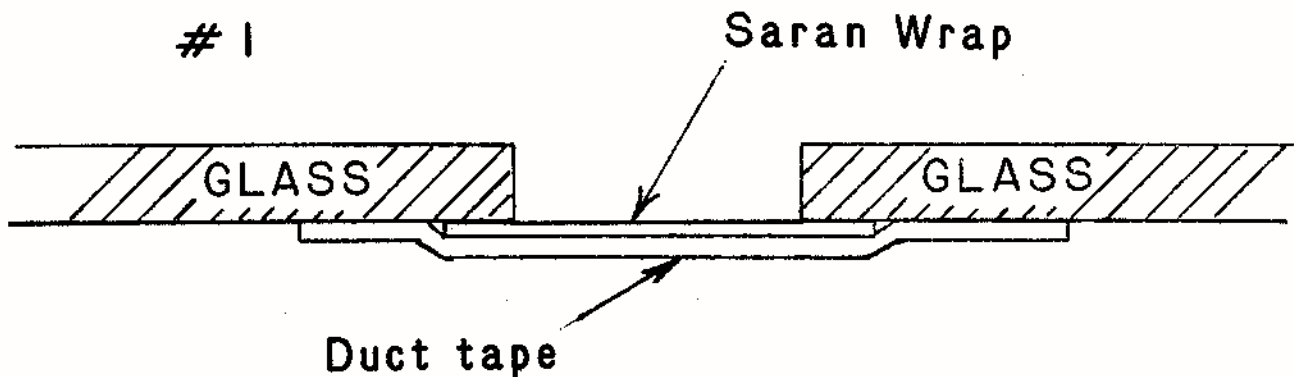
Cut a strip of Saran wrap 1 inch wide and stick it on the center of a piece of 2 inch wide duct tape the length of the width of the window. Stick the duct tape to the inside of the window as shown in drawing #1. This will hold the two pieces of glass together and the Saran wrap will make it easier to remove when complete.

Cut existing rubber from between the pieces of glass and clean thoroughly with lacquer thinner.

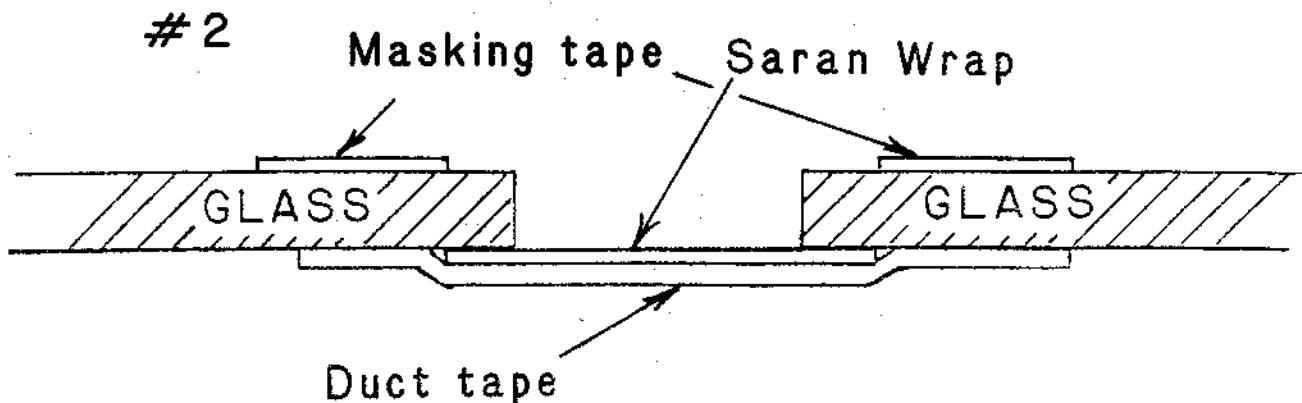
Put a strip of 3/4 inch masking tape on each side of the opening approximately 1/4 inch from each edge as shown in drawing #2.

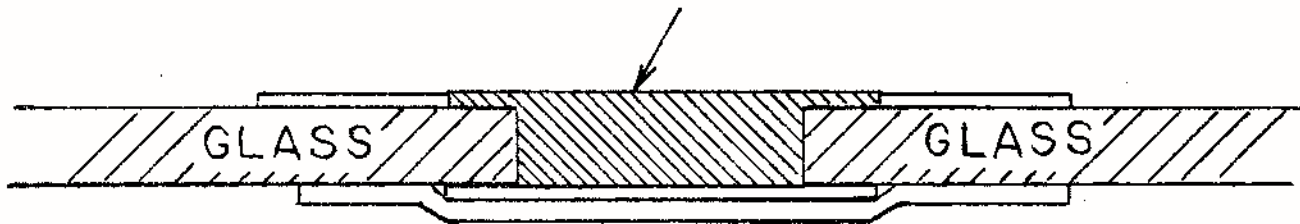
See drawing #3

Silicone caulking

Using a good grade of clear silicone caulking fill the opening to the top of the masking tape. Use a putty knife to smooth the caulking flush with the top of the masking tape and allow to cure for 24 hours.

Using a razor blade, cut along the edge of the masking tape next to the silicone, then peel off the masking tape. Peel the duct tape and Saran wrap from the inside and the job is complete.
